# Wake County Stormwater Control Measure (SCM) Inspection Report

Wallbrook Townhomes / Approved

**Permit Name:** Wallbrook Townhomes

**Permit Number:** SWF-084502-2022

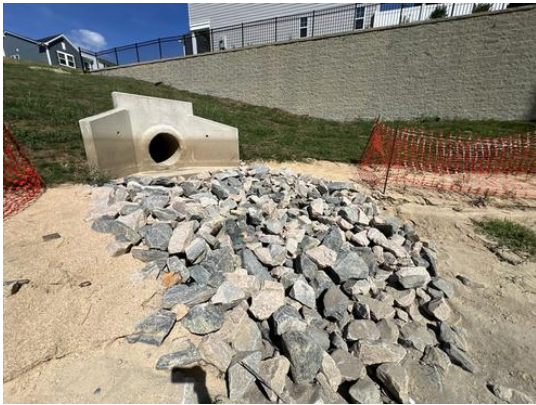
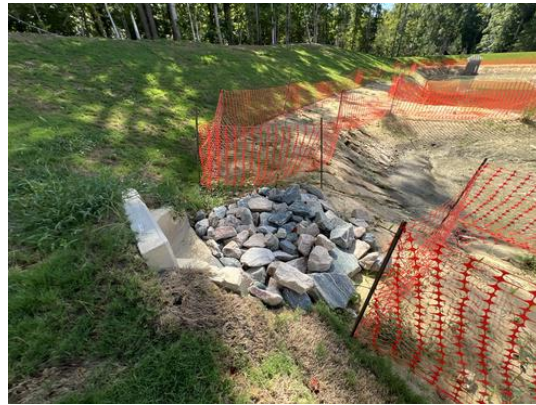
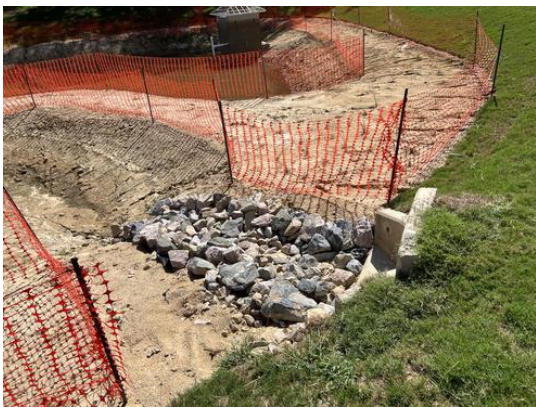
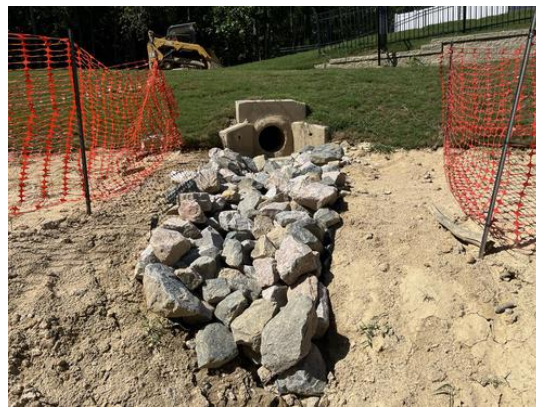
**Inlet to SCM condition:**

Installed per plan and in good working condition.

Riprap installed per plan and functioning properly.

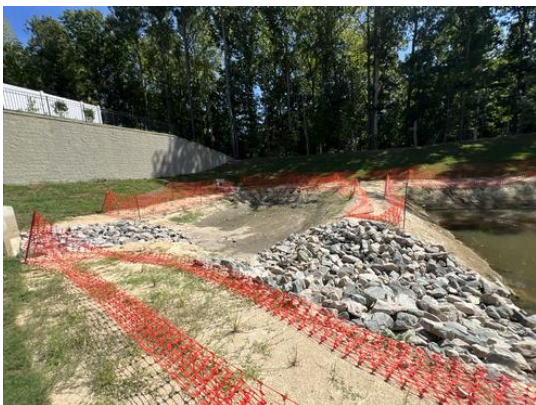
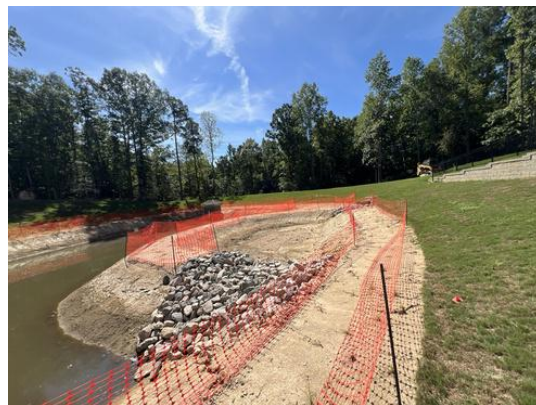
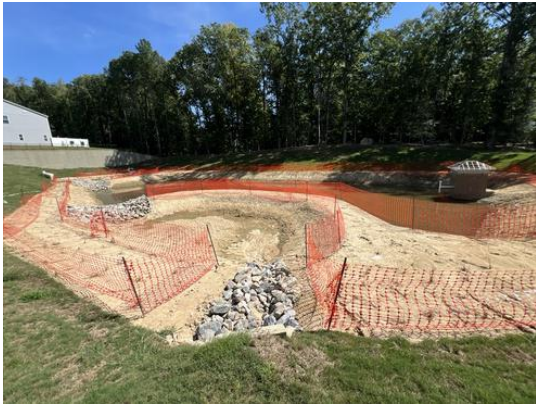
**Forebay installed per plan and in good working condition:**

Yes

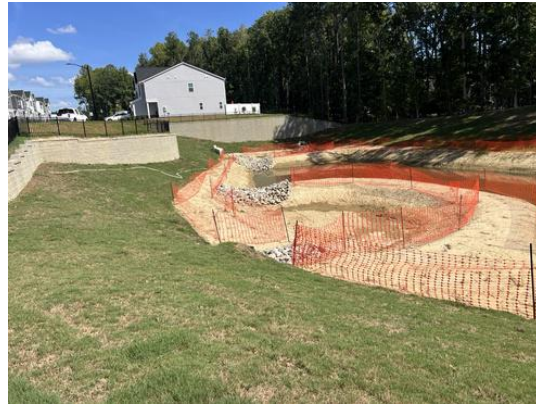
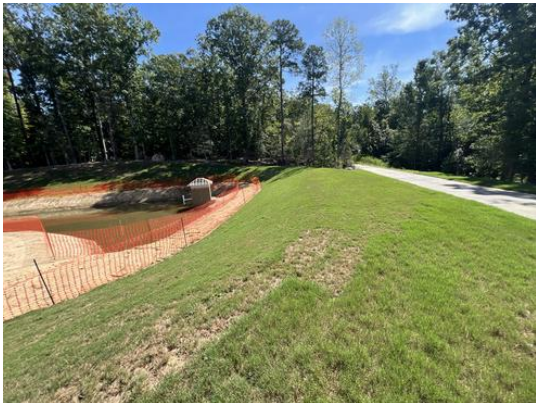
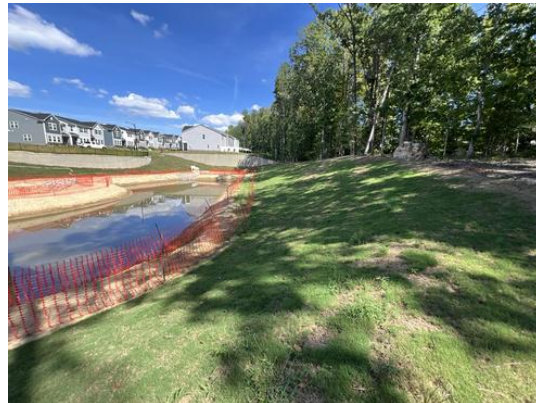
**Stabilization of areas in and around SCM:**

Good

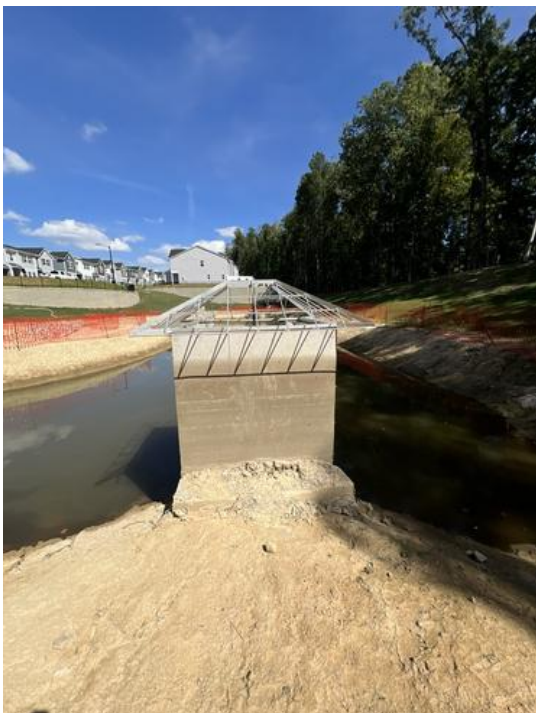
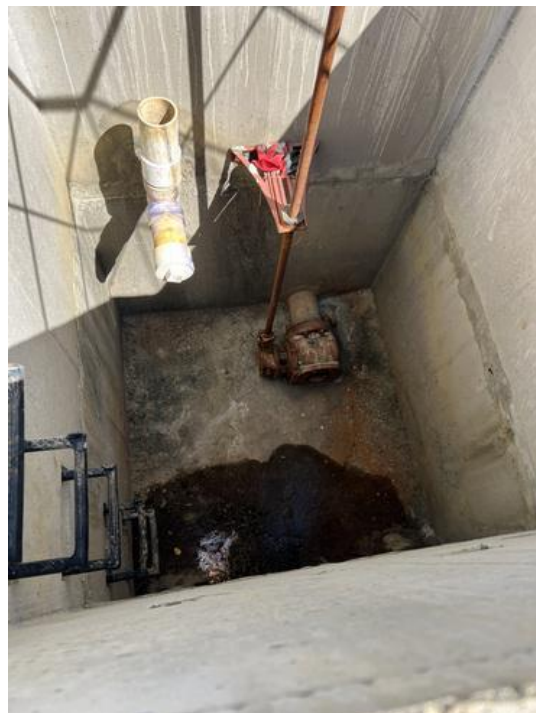
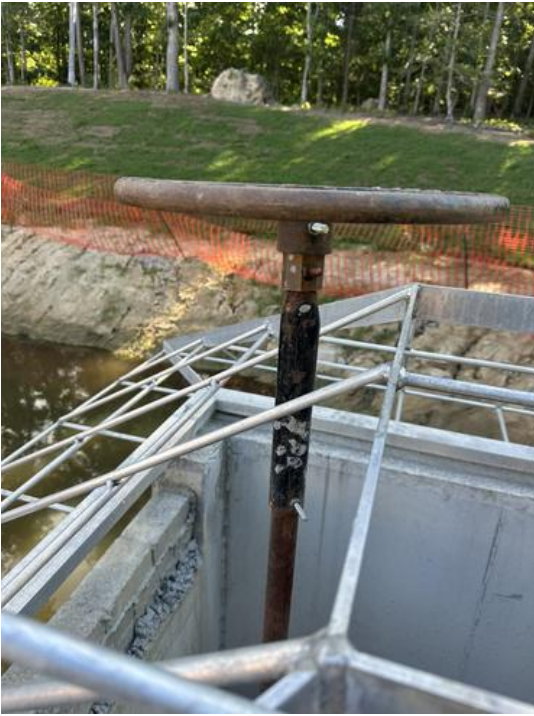
**Riser structure condition:**

good working condition

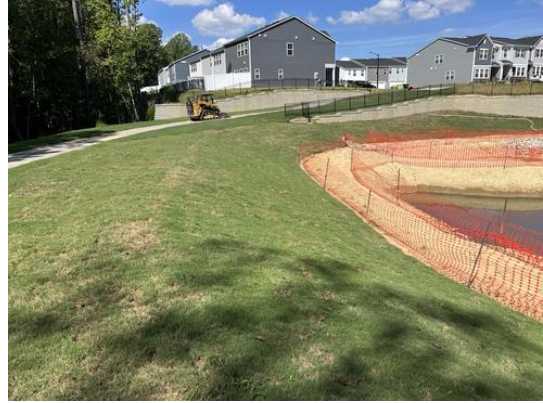
Photo 14

**Condition of dam:**

good working condition

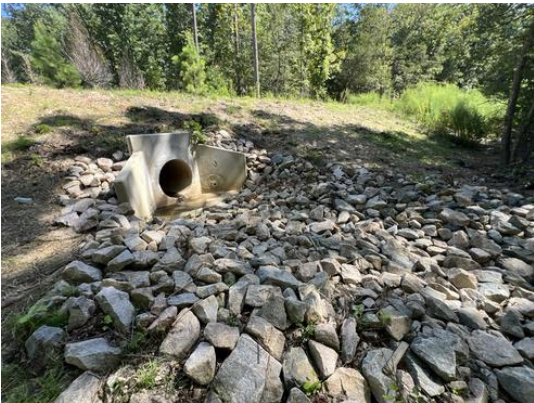
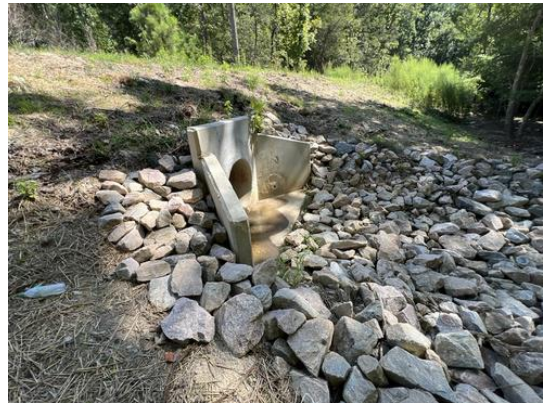
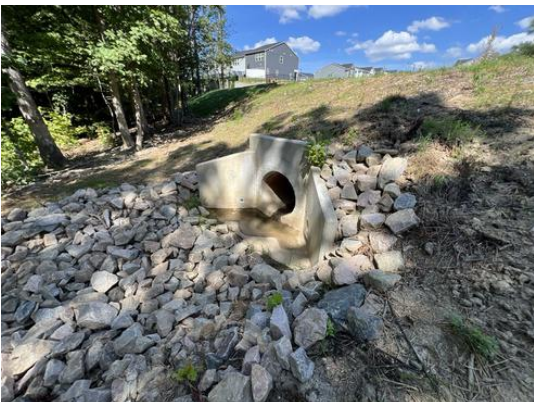
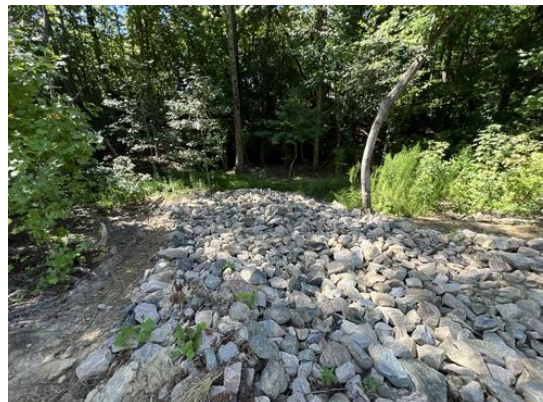
**Outfall to SCM condition:**

good working condition

Outfall is stable. No signs of erosion at time of inspection.
